U.S. ARMY AIRCRAFT ENGINE COMMAND
ENGINE DEVELOPMENT CENTER

T85-L-714 ENGINE
DEVELOPMENT AND QUALIFICATION

ENGINE M11
LOW CYCLE FATIGUE TEST REPORT
LYC 87-14
(0213-005-87)

DECEMBER 1987

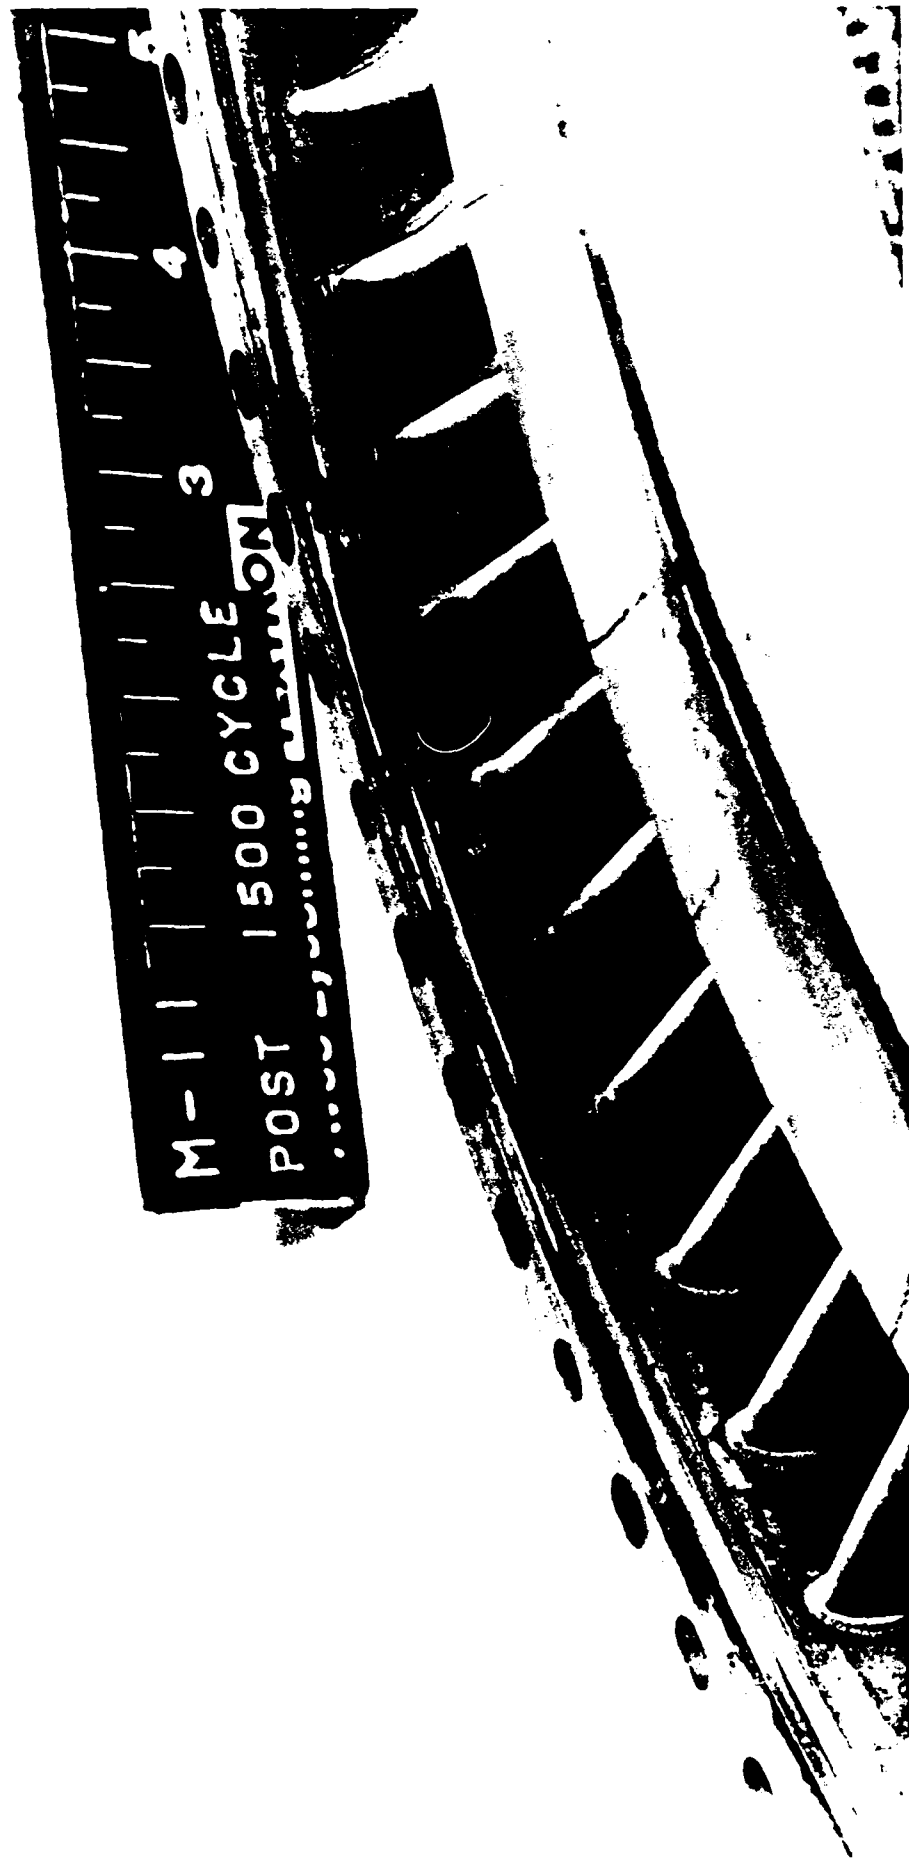
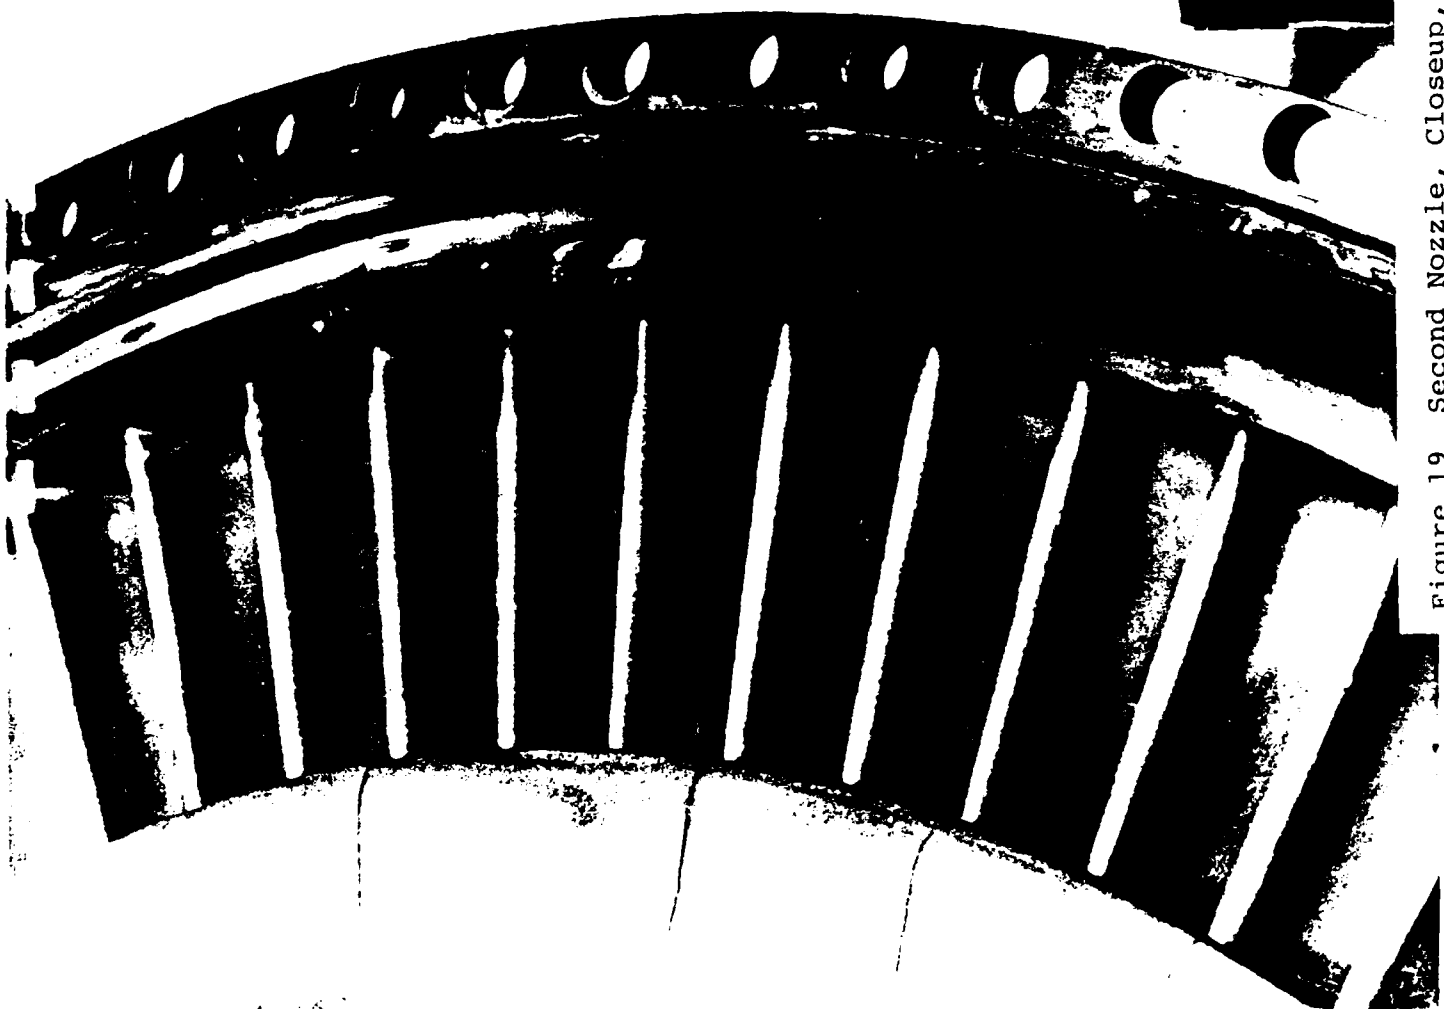
Second Nozzle Assembly - Vane condition was excellent with no evidence of thermal distress. There was some axial cracking of the cylinder and numerous cracks in the sheet metal diaphragm. There was a braze separation at the leading edge of the outer shroud spanning an arc of approximately 20° (Figure 18). The posttest inspection showed no change in the separation. The flex baffle repair gave improved durability over the original configuration. Figures 17-20.

Figure 17 Second Nozzle, Front, Inner and Outer Shroud
Cracking, Post 1500

Figure 18 Second Nozzle, Braze Separation, Post 1500

Figure 19 Second Nozzle, Closeup, Inner and Outer Shroud
Cracking, Post 1500

Figure 19A Second Nozzle, Front, Inner and Outer Shroud
Cracking, Posttest

Figure 20 Second Nozzle, Rear, Inner Shroud Cracking,
Post 1500

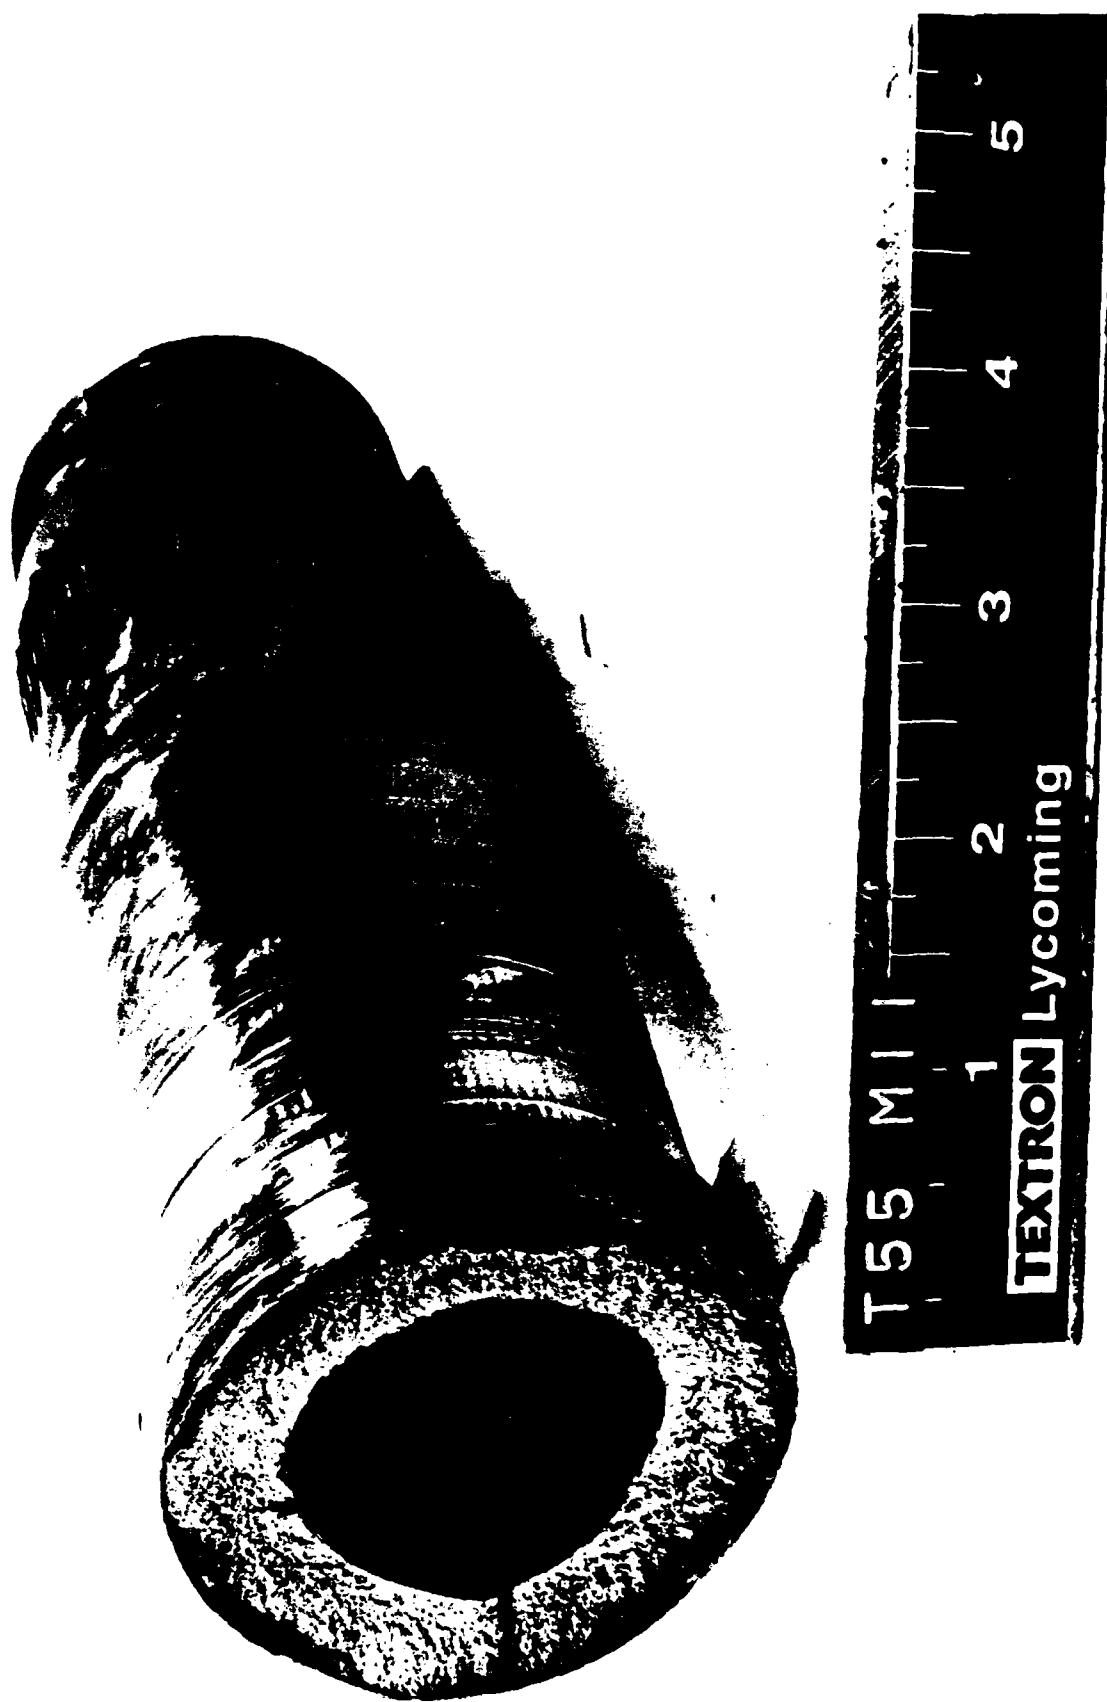
Third Turbine and Power Shaft - There were no significant discrepancies noted at the post 1500 cycle inspection. As the photographs show, posttest damage was extensive. Regarding the blades, there was no evidence of radial pull out from the disc or fatigue on non damaged fractures. Separation of most blades was by impact/bending. Some blades were displaced axially though of the remaining blades in the disc, none were found to be loose. The separation of the power shaft forward of the disc, near the weld interface was the result of axial/torsional tensile overload. Separation forward of the weld is radial tensile (impact/bending). The separation forward of the aft inertia weld was primarily axial with a torsional component (all tensile). Figures 34-39.

Figure 34 Third Turbine and Output Shaft, Front, Post 1500

Figure 35 Third Turbine, Closeup of Blade Roots and Rivets, Post 1500

Figure 36 Third Turbine and Output Shaft, Rear, Post 1500

Figure 37 Third Turbine and Shaft Fracture Surface, Front

Figure 38 Third Turbine and Shaft Fracture Surface, Rear

Figure 39 Output Shaft, Rear Section, Fracture Surface and Scoring

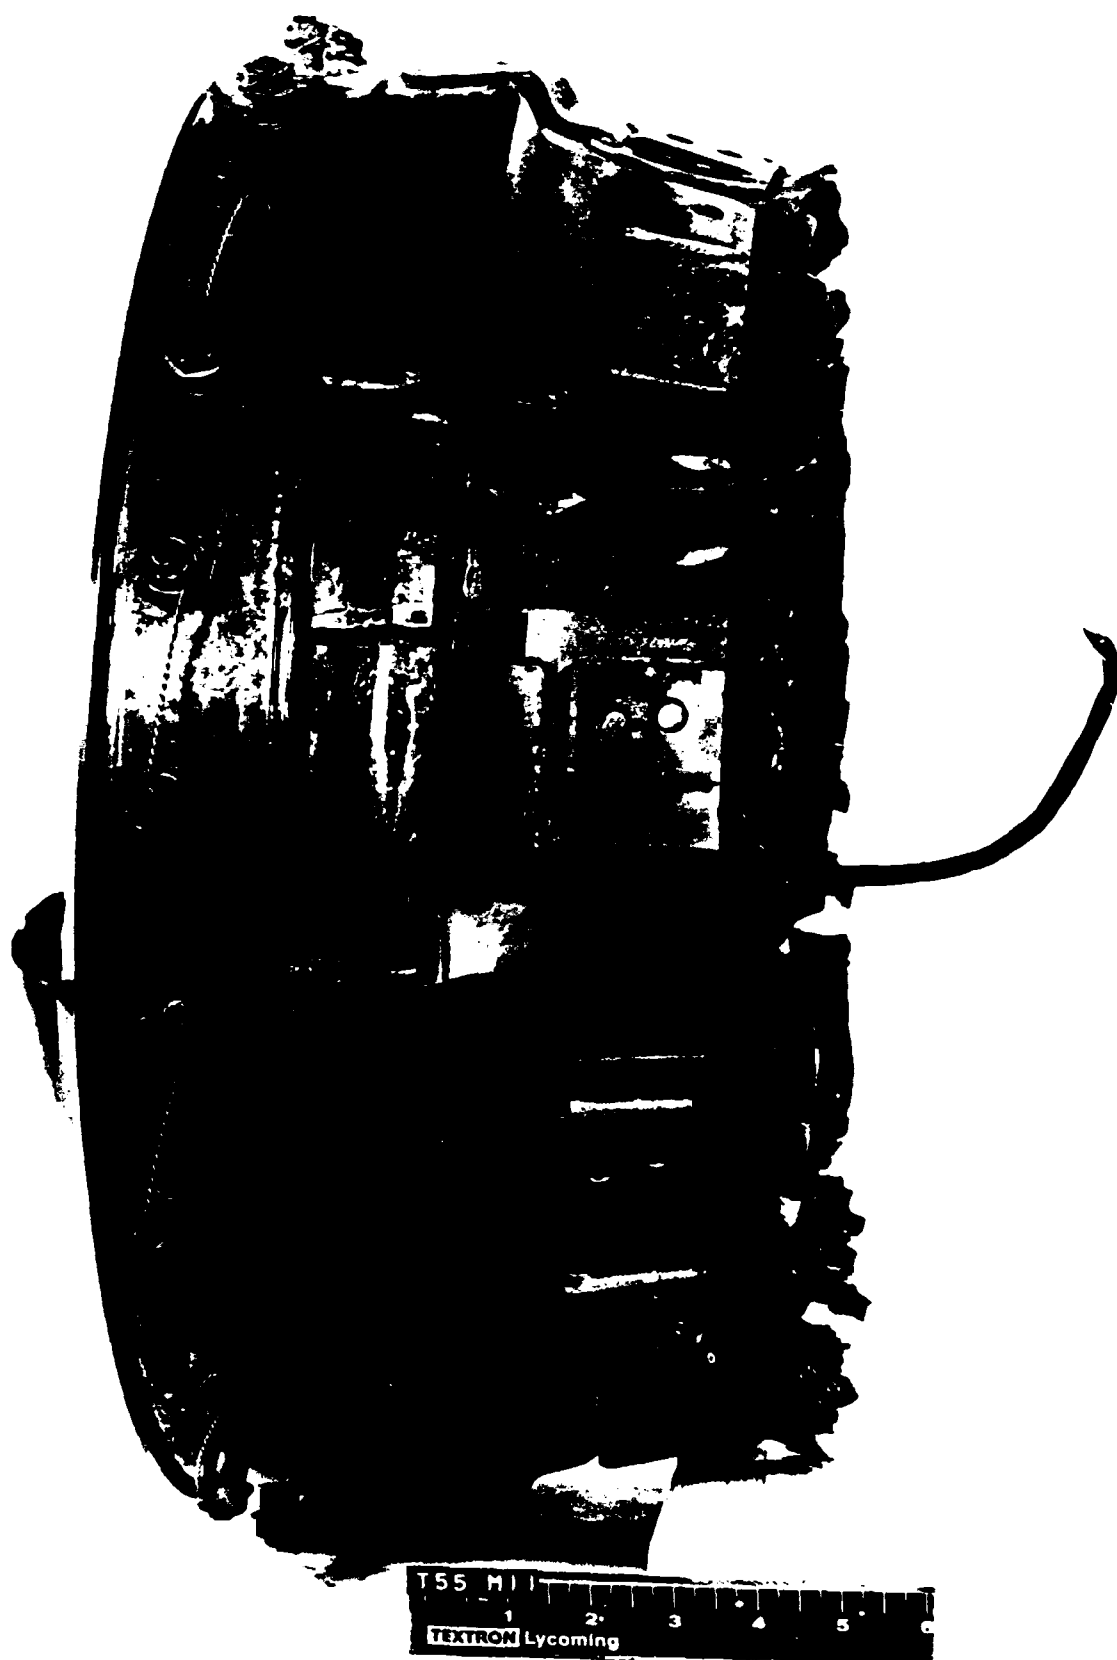
Fourth Nozzle Assembly - The assembly was in very good condition after completing 1500 cycles. In the failure sequence, the assembly separated from the engine. This was the result of circumferentially sheared forward flange bolts and a shear separation of the nozzle aft of the seam weld. The seam weld is acceptable. Figures 44-46.

Figure 44 Fourth Nozzle Assembly

Figure 45 Fourth Nozzle Assembly with Fourth Turbine and
Exit Stator Ring, Front

Figure 46 Fourth Nozzle Assembly with Fourth Turbine and
Exit Stator Ring, Rear

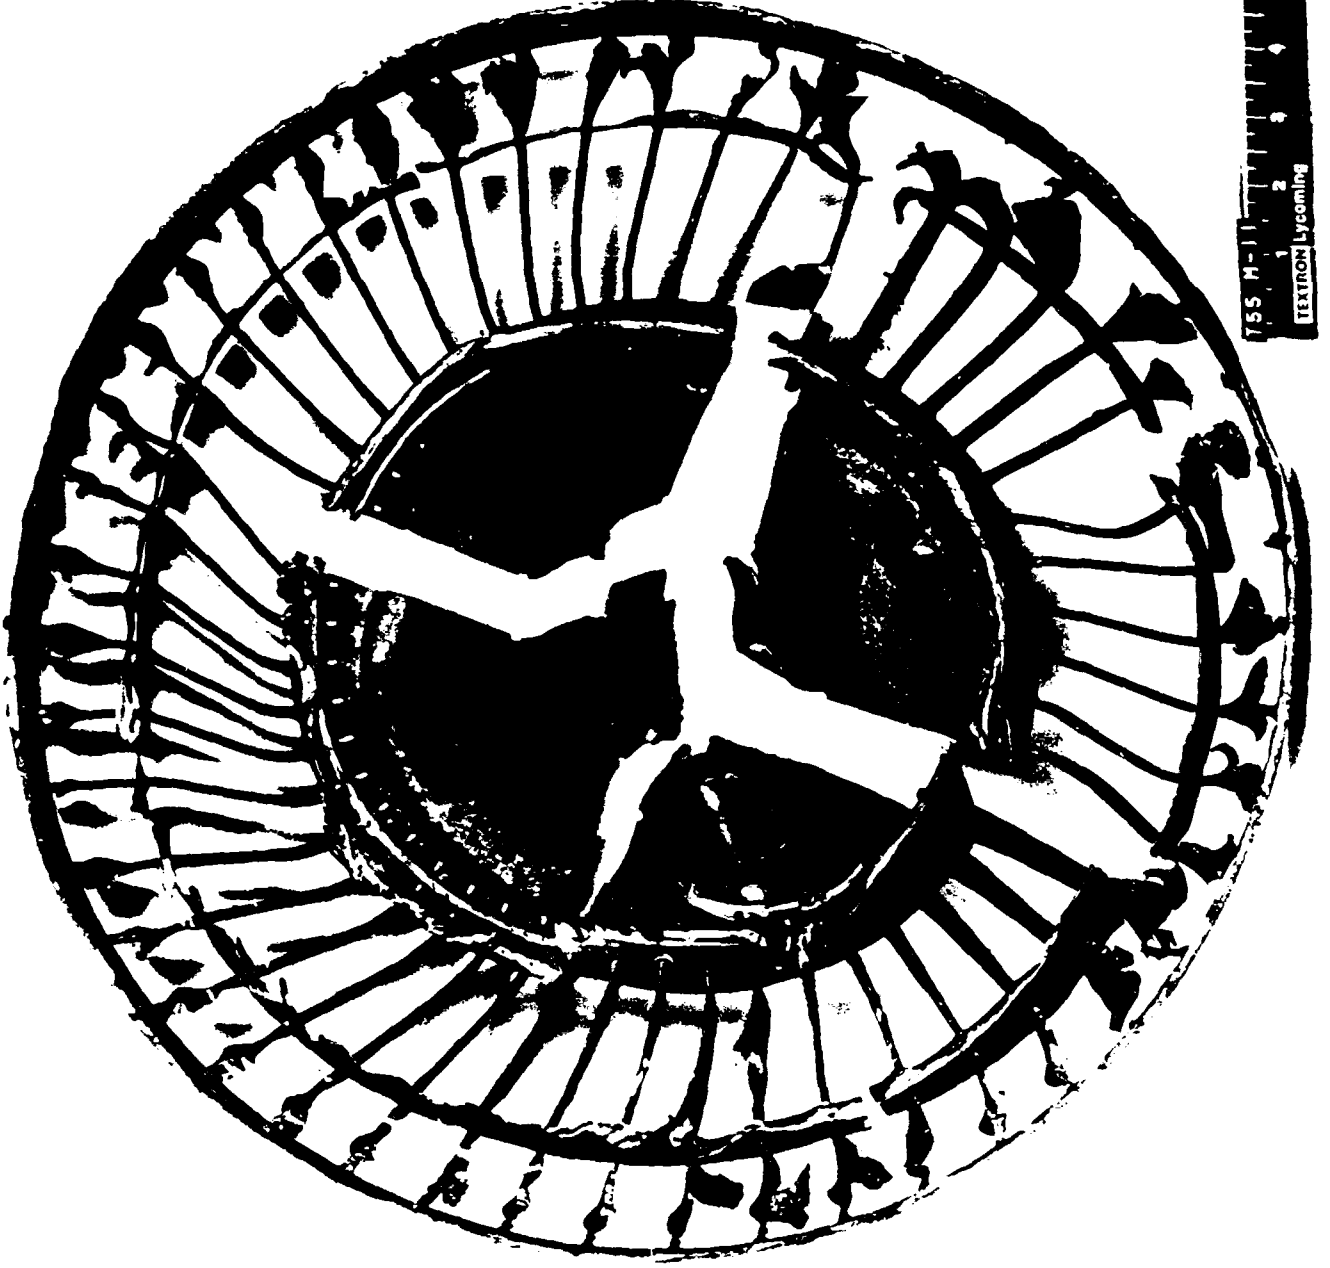
Exit Stator Ring - The stator ring was in excellent condition after completing 1500 cycles. The ring remained attached to the fourth nozzle assembly after assembly separation. The fourth stage blades were contained by the ring. Figures 46-48.

Figure 47 Exit Stator Ring, Rear, Post 1500

Figure 48 Exit Stator Ring, Front

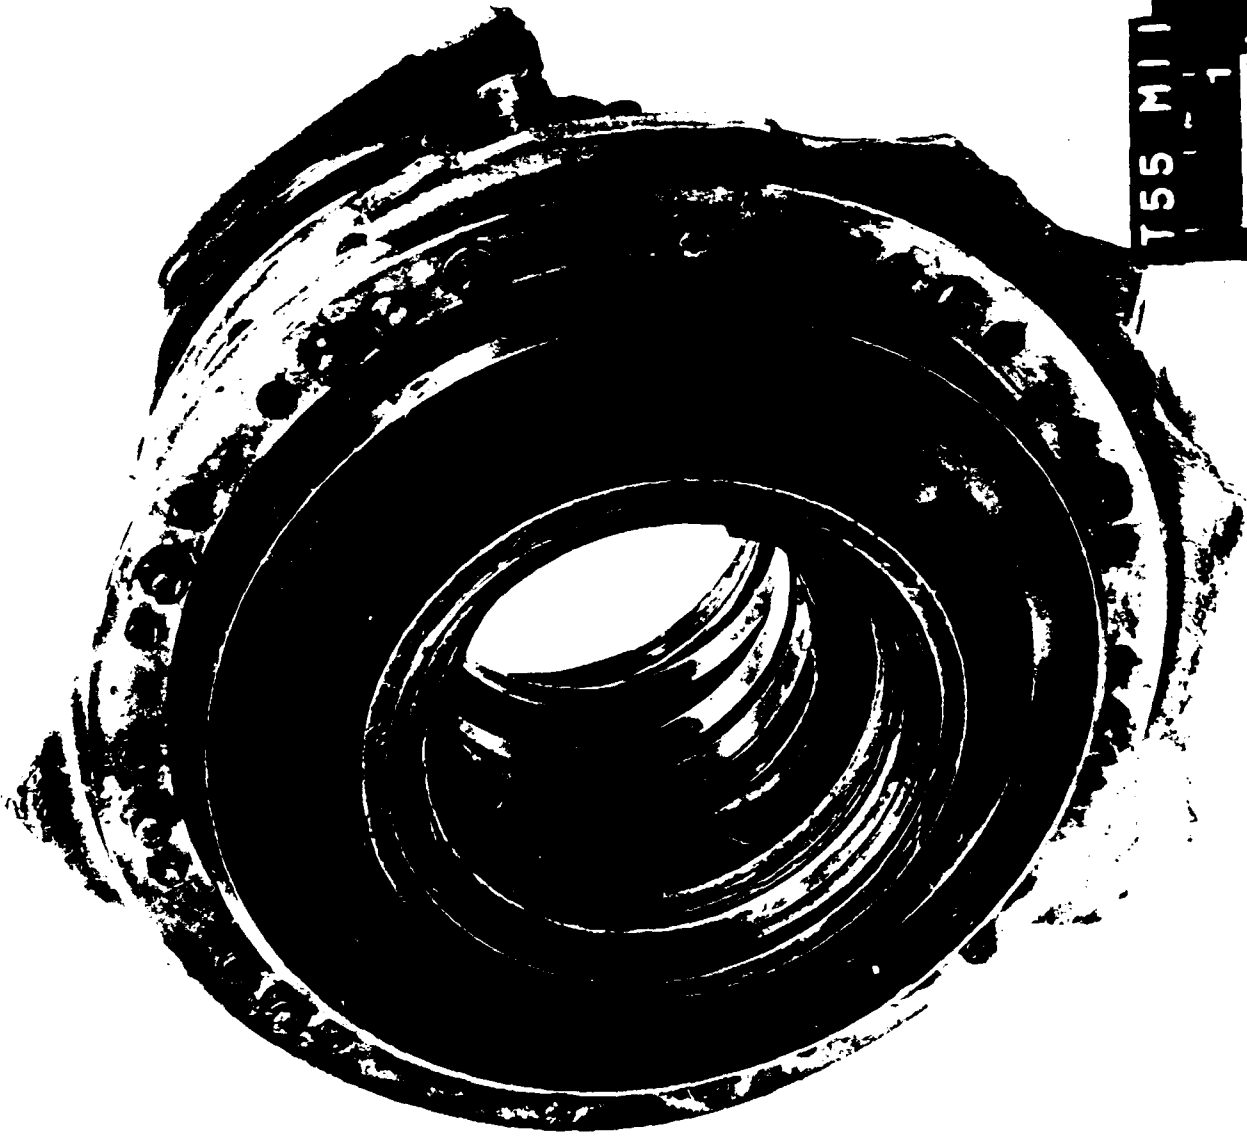
Number 4 and 5 Bearing Package - Data taken during testing shows that the 4 and 5 bearing package was operating normally right up to the failure. The package was separated from the engine because of failure of its supports due to axial and shear tensile overload. All bearing damage was secondary. Figures 49 & 50.

Figure 49 Number 4 and 5 Bearing Package, Front

Figure 50 Number 4 and 5 Bearing Package, Rear

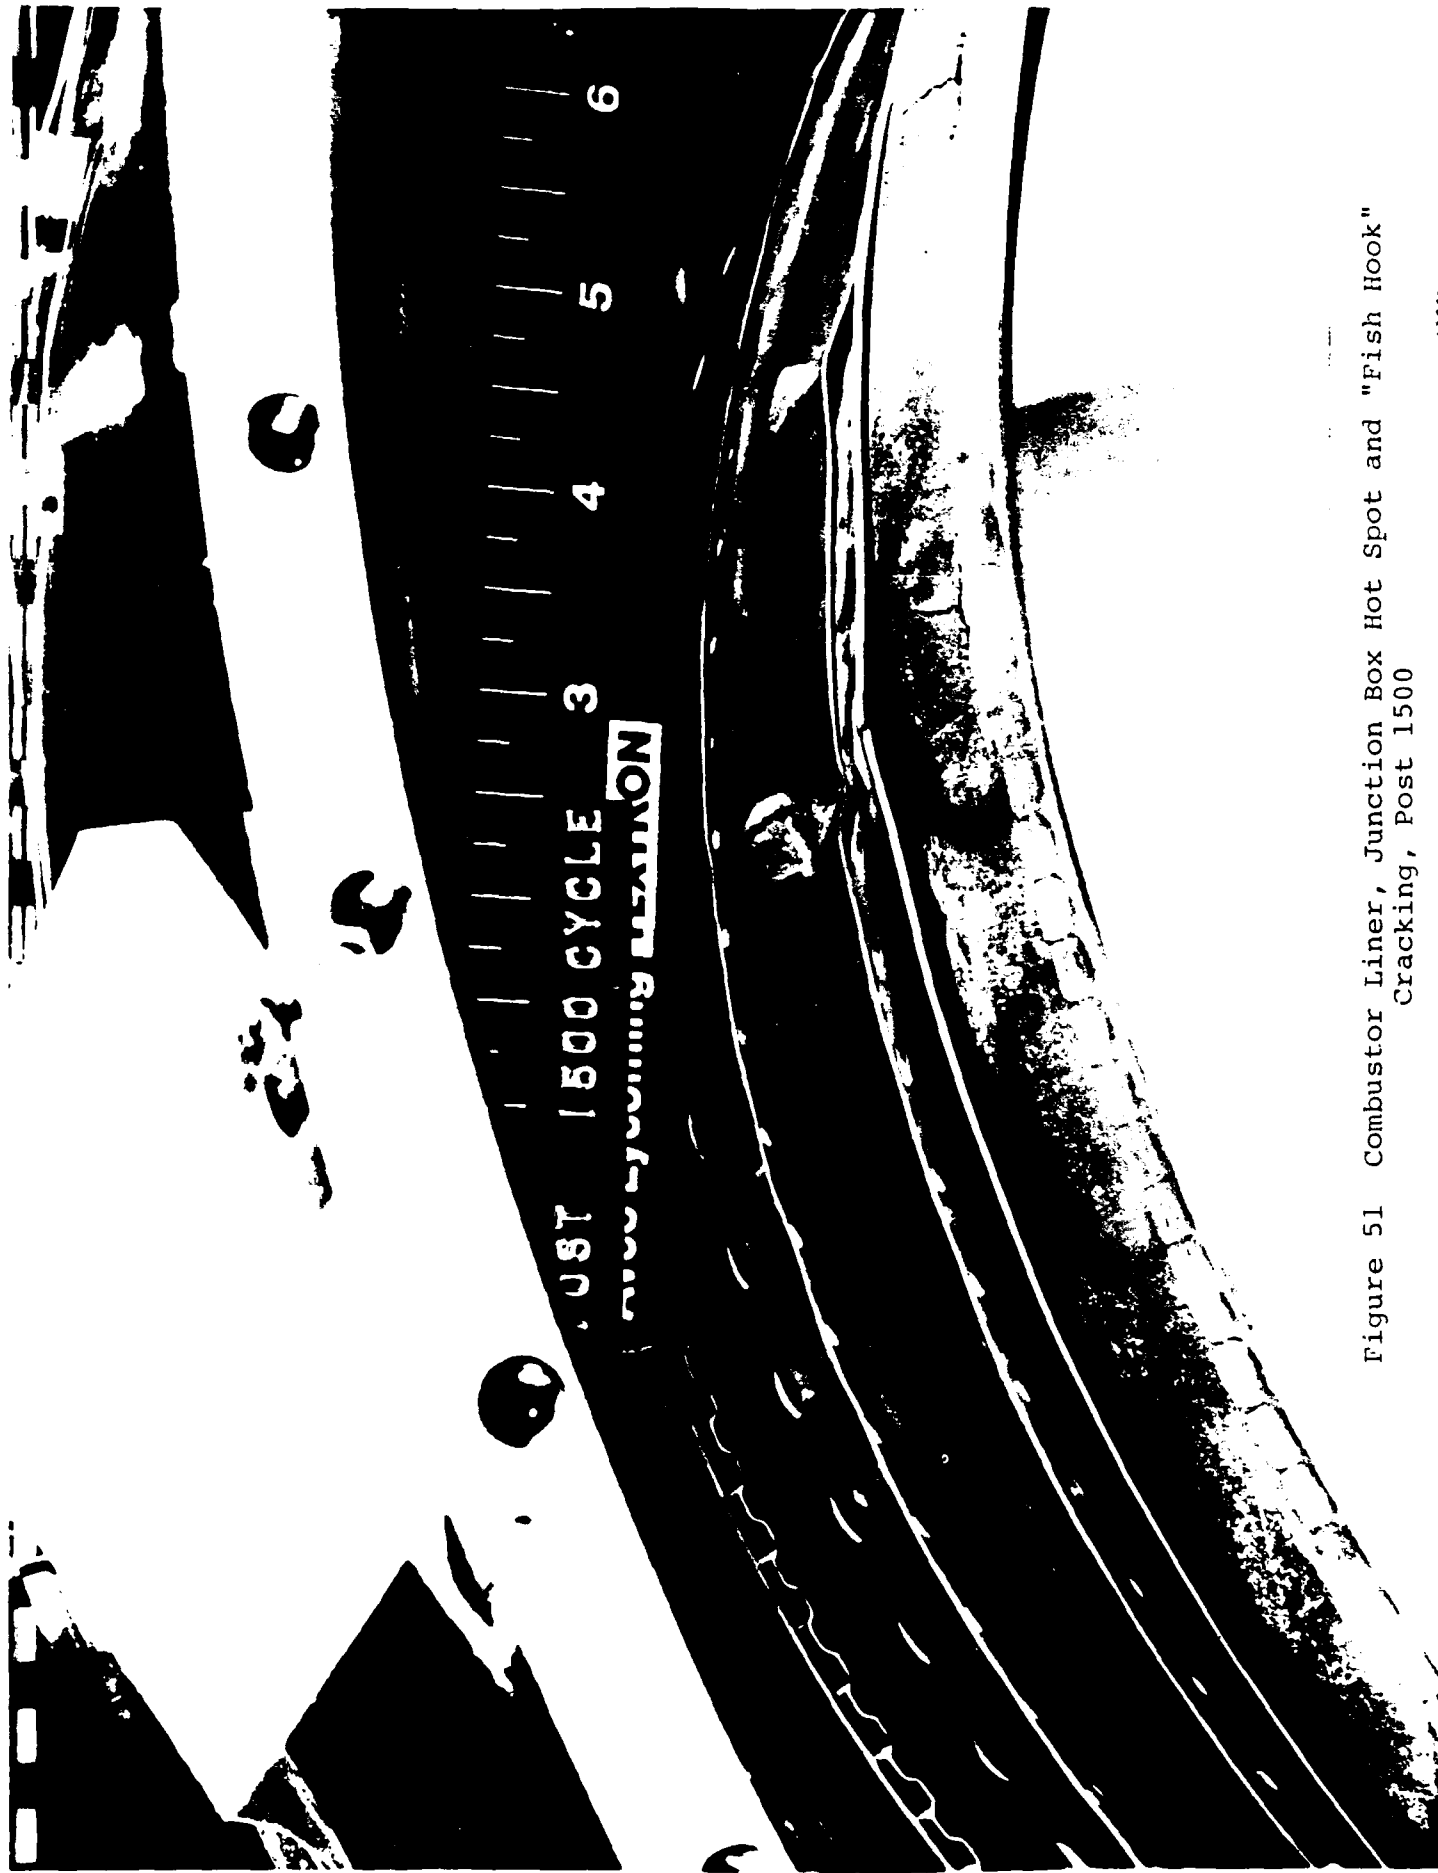
Combustor Liner - The liner completed 1500 cycles in very good condition overall. There was some cracking in several panels and the "fish hook". Figure 51.

A notable discrepancy was five "bumps" that formed during testing. Figures 51-53. They coincide with the location of the five MGT harness junction boxes and were first noticed during the post 500 cycle inspection. The bumps and cracks increased slightly by the end of 1000 cycles. Observations made at the 1500 cycle inspection and during the MGT probe replacement at 1700 cycles revealed little change. It is felt these are a result of the higher operating temperatures for this test and a restriction of the cooling airflow, in that area, by the junction boxes; their presence was not deleterious to engine durability and operation.

Figure 51 Combustor Liner, Junction Box Hot Spot and "Fish Hook"
Cracking, Post 1500

Figure 52 Combustor Liner, Junction Box Hot Spots and
Panel Cracking, Post 1500

Figure 53 Combustor Liner, Junction Box Hot Spots and
Panel Cracking, Post 1500
